## The Flanagan Corporation

### Cerritos Performing Arts Center

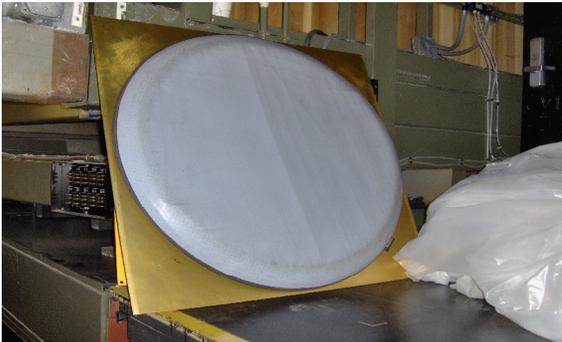
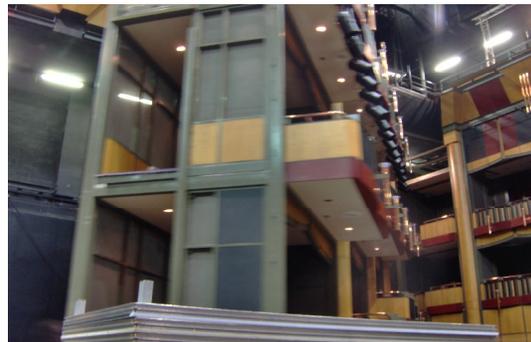
I have to admit this was one of the most challenging jobs to specify materials for. Typically you lean on past experiences but this job was so unique that past experiences were not available to me. Cerritos Performing Arts Center is a one of a kind transforming auditorium. It has 7 different configurations to accommodate a multitude of events. Because of this unique feature the floor that needed a coating would see some very unusual forces. In order to move the walls of the auditorium to configure for different venues they had to rely on a hovercraft system to slid the walls into place. Although the hovercraft system was very effective to alleviate a lot of the weight of the walls each wall still weighed upwards of 180 tons.

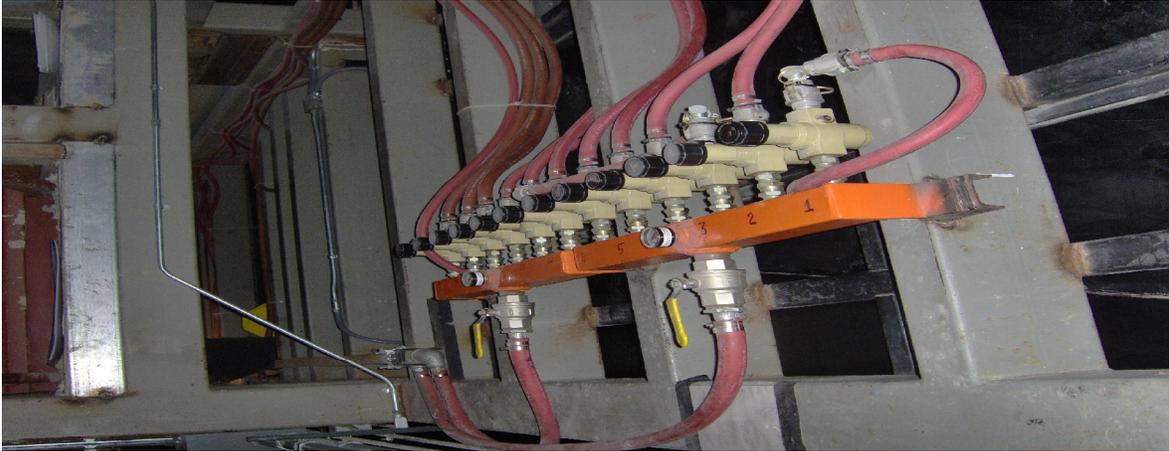
When considering the different coating options we had to consider not only the abrasion of the hovercraft pads sliding across the floor but also the working environment. Due to the sensitivity of the job site there were no spray applied coatings that were allowed. We had to choose a role applied coating system and still achieve a durable coating system. One of the other factors that come up was once the floor was moved into place the weight of the walls resting on the floor. Once the hovercraft system moved the walls into place they would set the walls down onto the floor resting the weight of the walls on steel feet that would make for some very concentrated weight on those feet.

Taking into consideration all of the above details of the job we elected to go with a thin film coating. We knew that any thick film coating would only allow for the weight of the walls to leave imprints in the coating. We would be relying on the concrete sub straight to carry the load. Now that we narrowed down to thin film coatings we needed to select the most abrasive resistant coating that we could use. **We selected for this the fluoropolymer coatings that show some of the best scratch resistant properties on the market.** Due to the fact we were dealing with an auditorium the gloss of the coating was also a concern. We used flatteners in the coating to achieve a “semi gloss” finish. The primer selected was 2 part 100% solids epoxy primer.

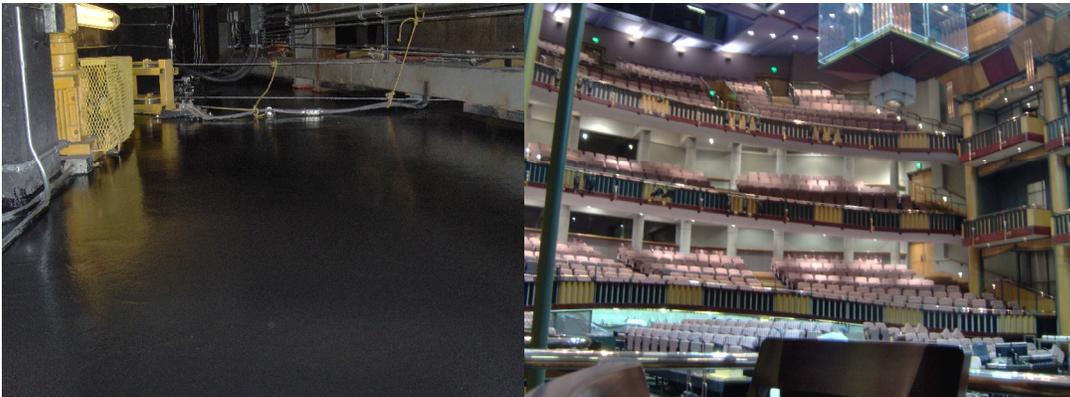
Do date we are having good results with the coating selection. They have moved the walls numerous times now and are seeing no damage to date.
